Home Performance Energy Report

Jane Doe
1234 Main Street
Anytown, MN

GENERAL SUMMARY

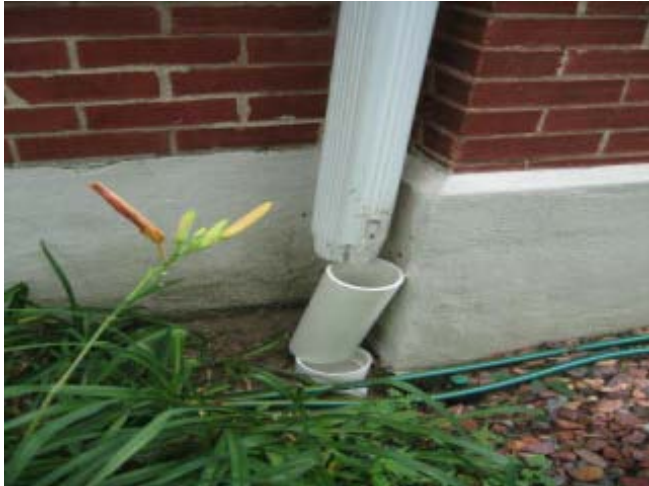
Downspout disconnected

1. Connect downspout.
2. Direct flue pipe away from siding on home.
3. Clean air conditioner coil.
4. Seal gaps and leaks at plenum on furnace. See photo.
5. Run fan on "auto" instead of "on", to determine if there are any noticeable differences. If not, there is little benefit to running the fan 24/7.
6. Research future water heater replacement.

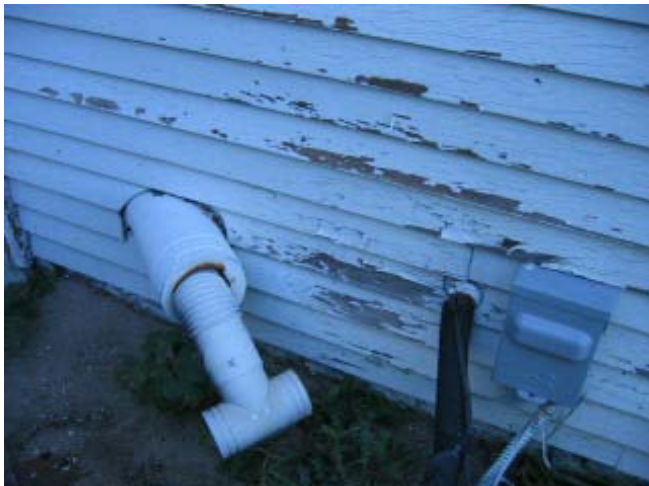
Flue pipe from boiler is directed against wall. Moisture in flue pipe is peeling the paint. Note the condition of paint in other areas is much better.

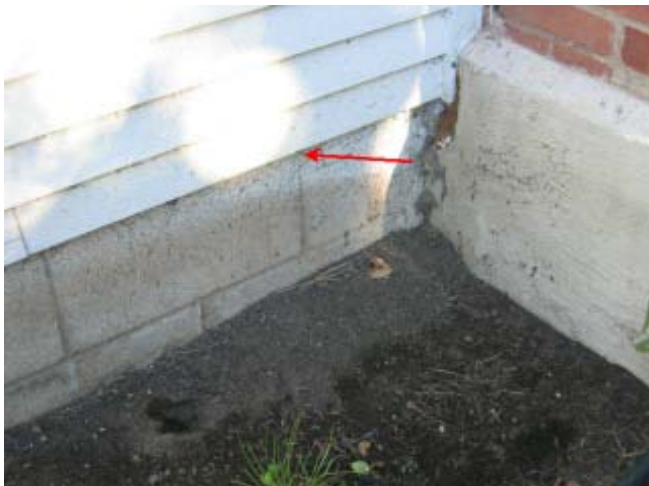
West side of crawlspace. Lip at red arrow makes exterior sidewall insulation easier to install. Excavate 1 - 2 feet below grade.

Waterproofing Inc has a good product for this. See next photos.

7. Seal attic by-passes (warm air leaks into the attic) as noted in the infrared photos.
8. Insulate crawlspace. This could be done from the exterior with a rigid foam product covered with aggregate. See Protecto-Coat XP from www.waterproofinginc.com The other option is from the interior although access is very difficult if not impossible in some areas. Exterior would be easier. For below grade, a cheaper cost product such as blueboard can be used to save on costs.

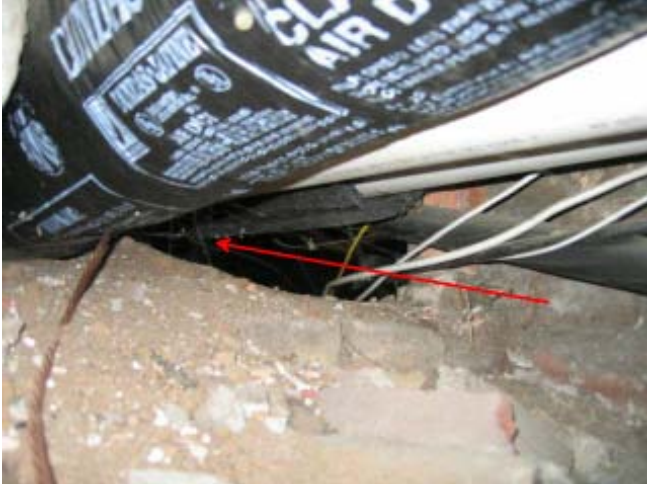
Crawlspace: Radiant barrier on floor joists. Could visually see that it has fallen down in many places. Also leaky. A video was taken of cobwebs flowing during the blower door test (see attached). Sealing the crawlspace and additional insulation is a critical component of the weatherization of this home.

Hard to see in this photo but if you look in this space with a flashlight, you can see the radiant barrier insulation has fallen down in many areas.

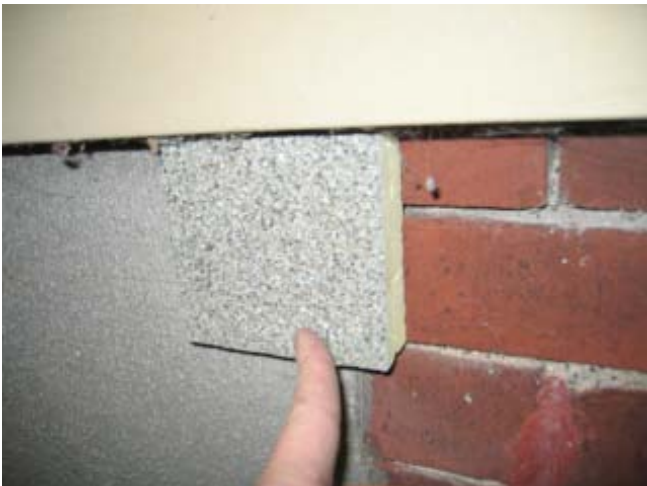
Exterior insulation covered with aggregate from the factory. Looks similar to concrete in color.

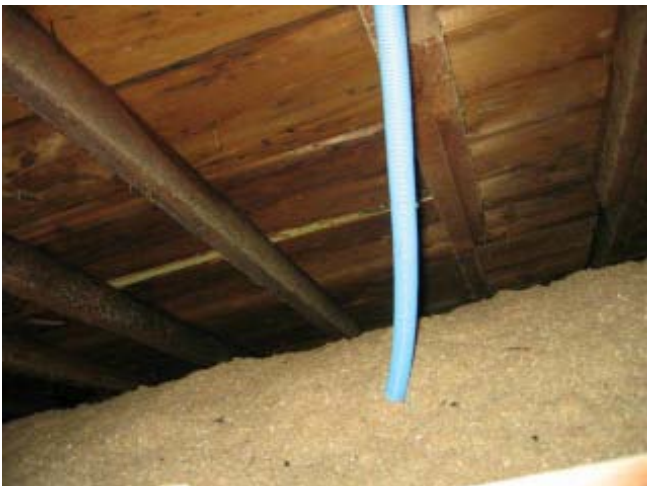
Attic: Not easy access due to tall dam. Lots of cellulose. Estimated high R-value but attic by-passes reduce the effectiveness of the insulation.

Blind photo of attic taken from ladder. Attic hatch dam too high to be able to get over it for inspection.

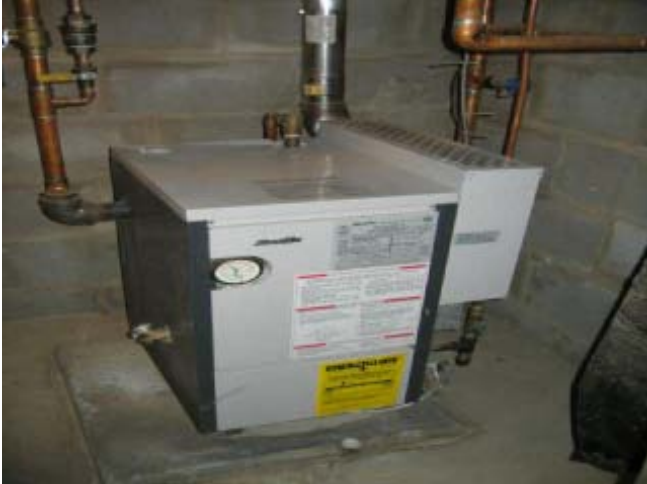
The heating system is a boiler which delivers in floor heat, a heat coil in the plenum of an air handler and the domestic hot water for the home. The unit is a side vented, 110,000 BTU/hr model installed in 2004. The side vented flue pipe is forced draft. The boiler has an estimated annual efficiency of 80+%.

2004, 110,000 BTU/hr input boiler, 80% efficient

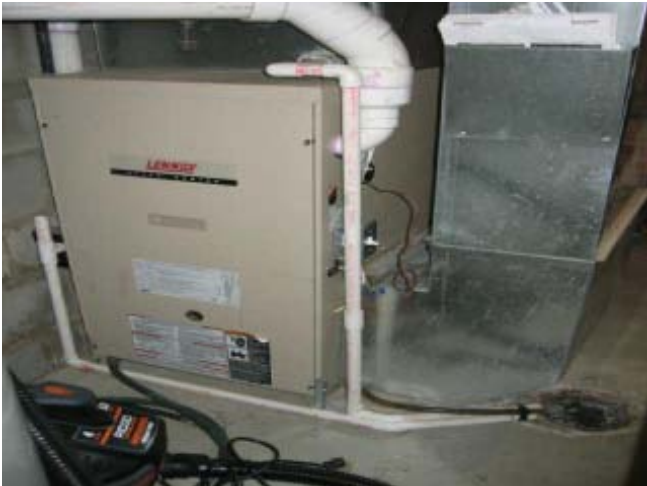
Air handler and air conditioning unit for second floor

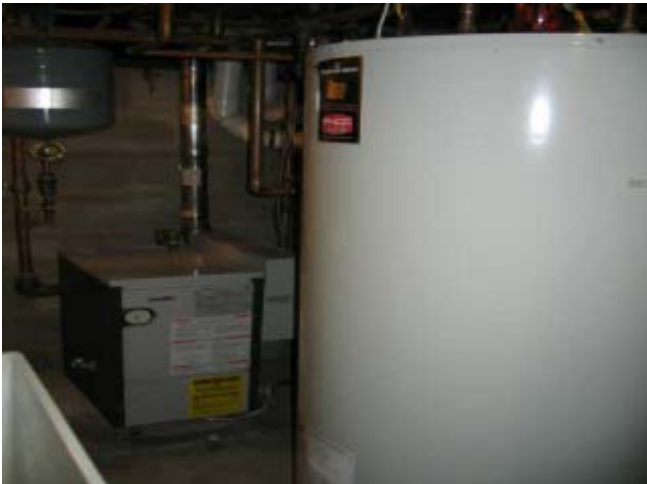
80 gallon storage tank for domestic hot water use

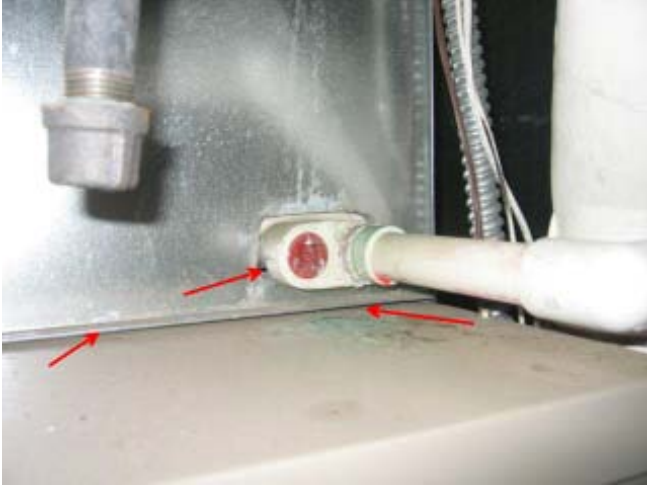
Air leaks into furnace area from leak in the plenum

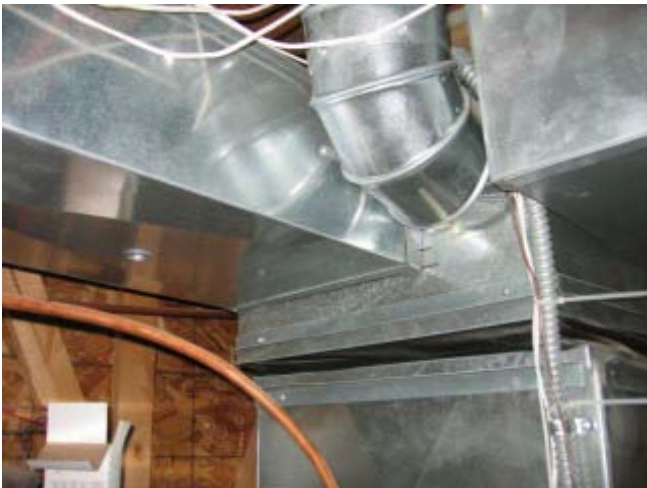
Air leaks at plenum unnecessarily cool and heat the furnace space.

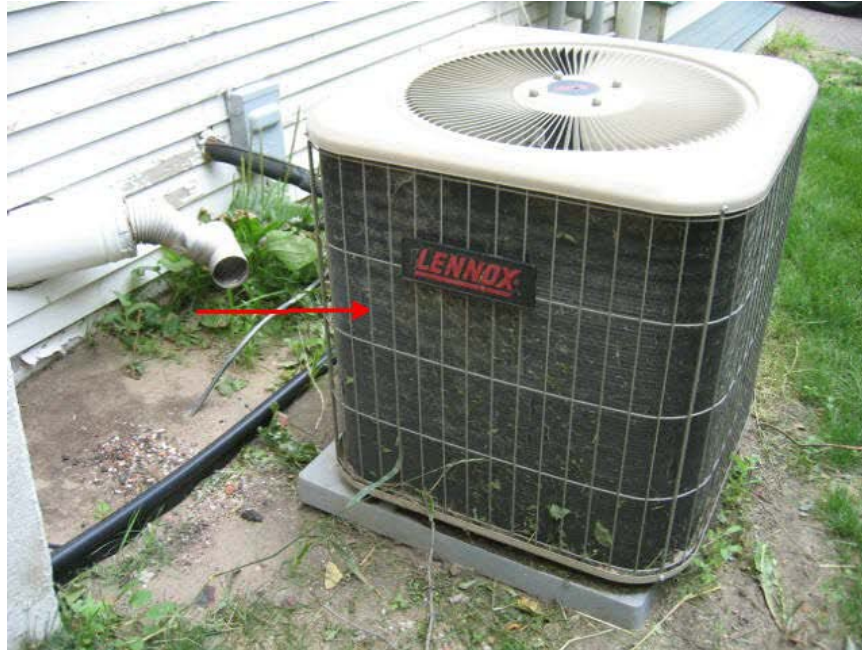
Exterior component of the cooling system. Installed in 2004, 3 ton, estimated SEER (efficiency rating) of 13.0. Coils are dirty and should be cleaned every season. Red arrow indicates coils.

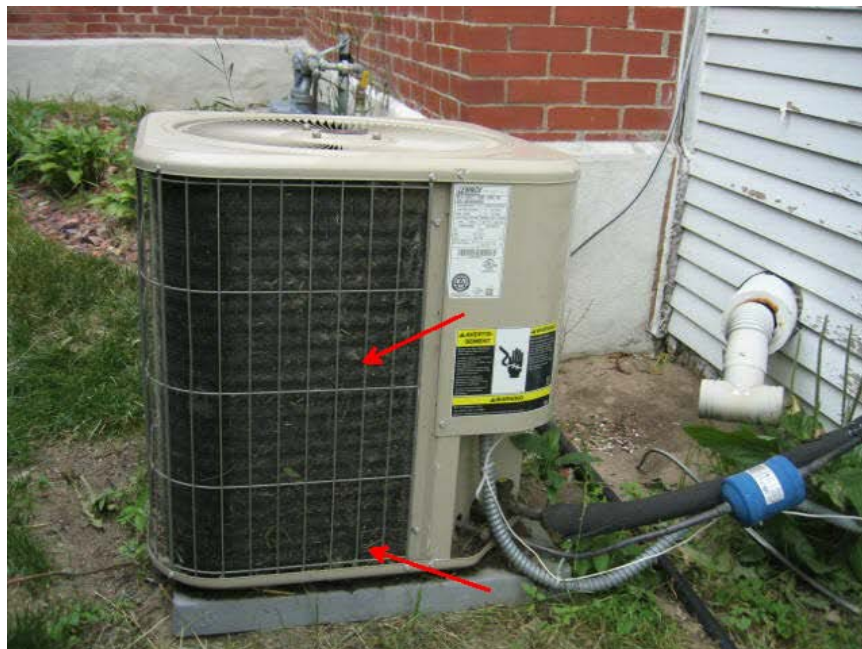
Coils are slightly dirty

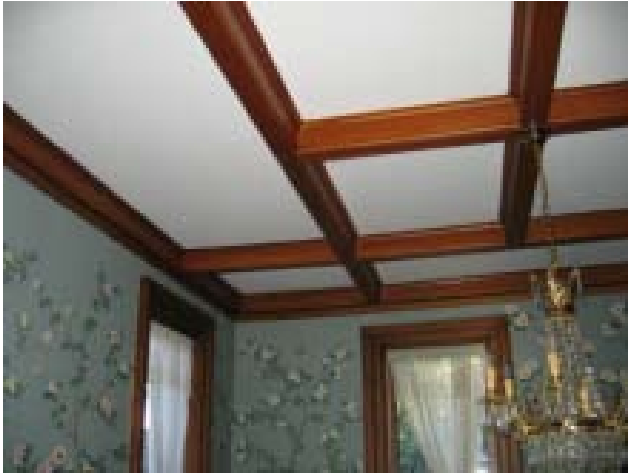
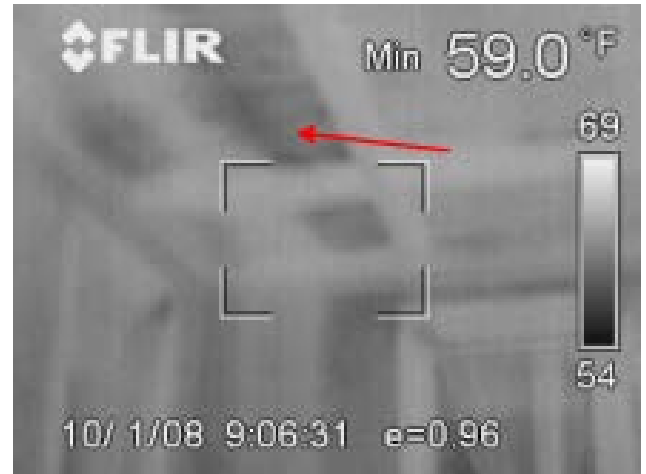
First floor dining room

Cold air traveling between the floors with blower door running. Old construction has no blocking between floor. Dark color represents cooler surface temperatures in all infrared photos.

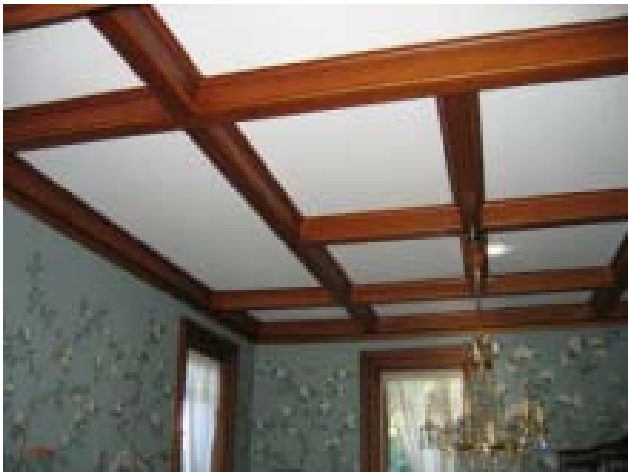
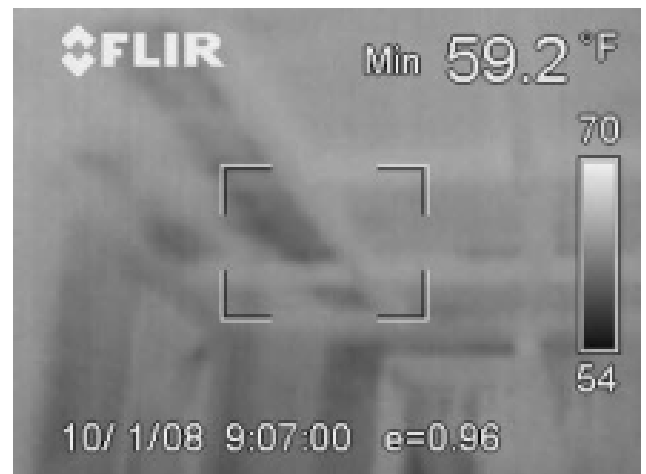
Similar shot of same area in dining room.

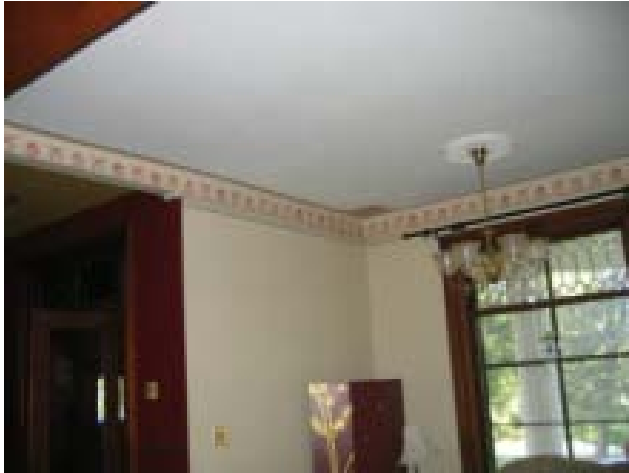
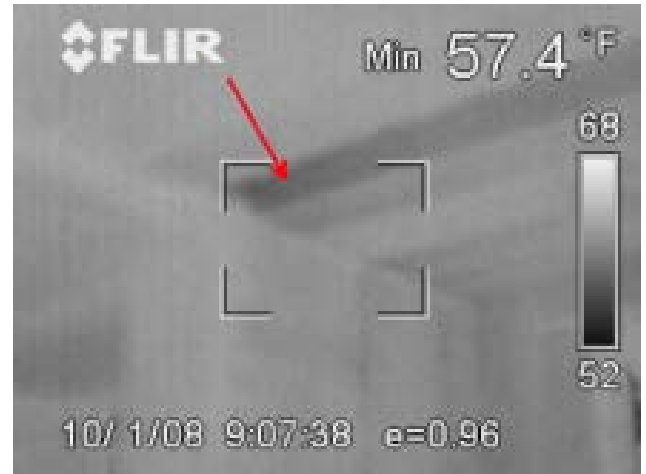
Near front entryway

Floor open to outside as shown with cold streak.

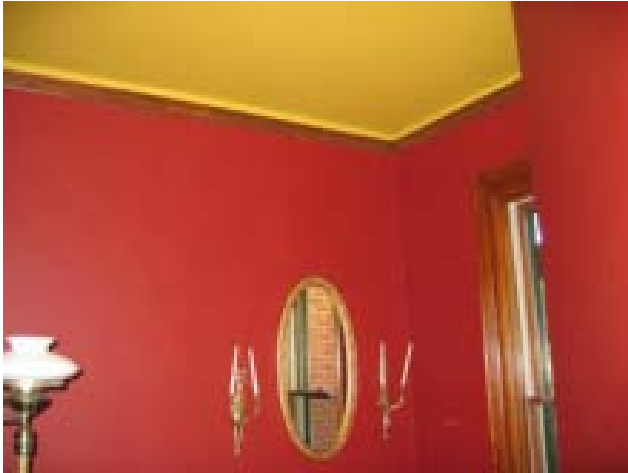
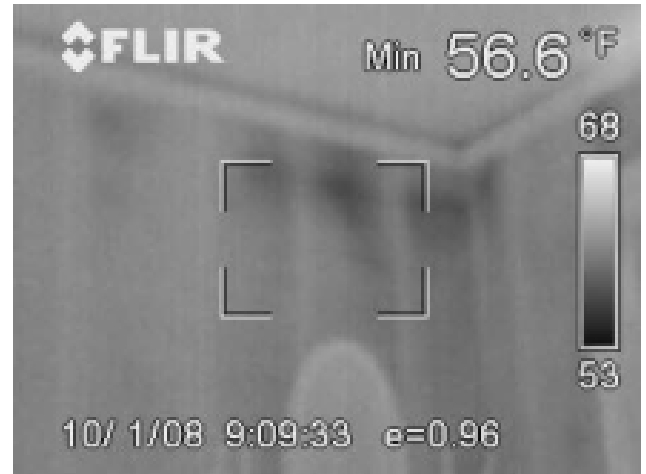
Second floor attic by-pass at interior wall.

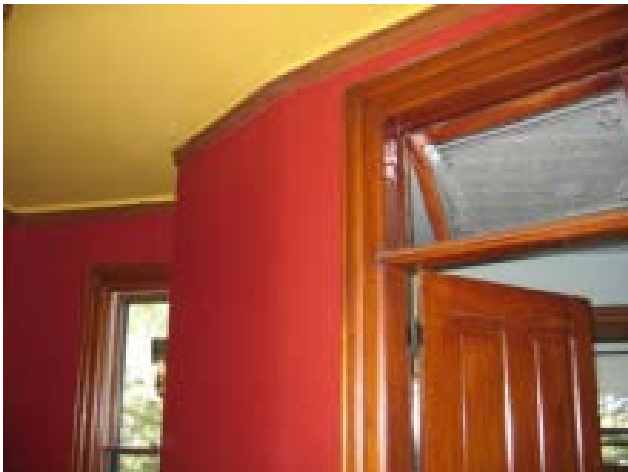
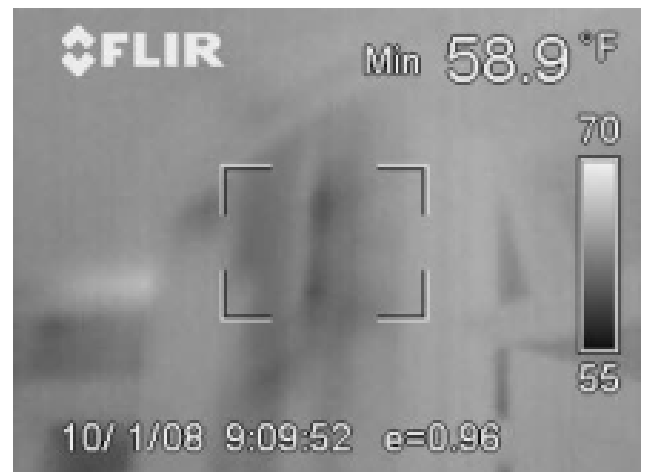
Closet interior wall is open to the attic. Could be sealed from the attic or the interior walls blown tight with densely packed cellulose insulation.

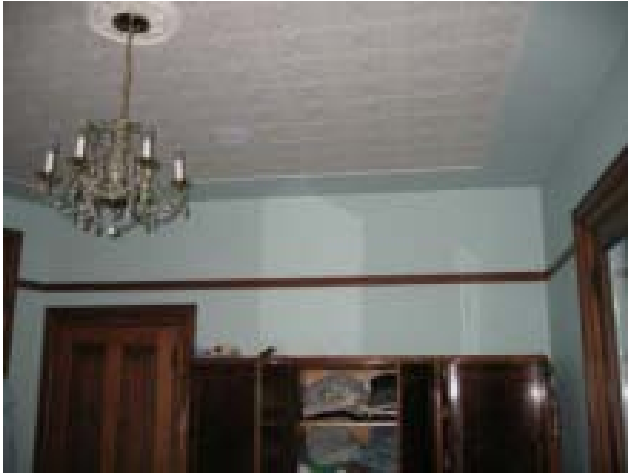
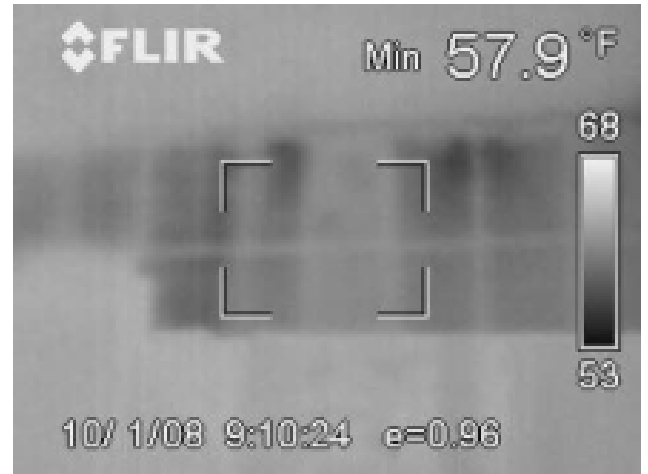
Same interior wall taken from other side

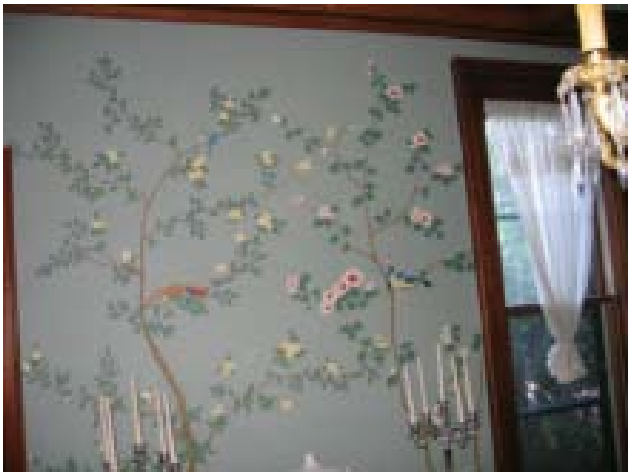
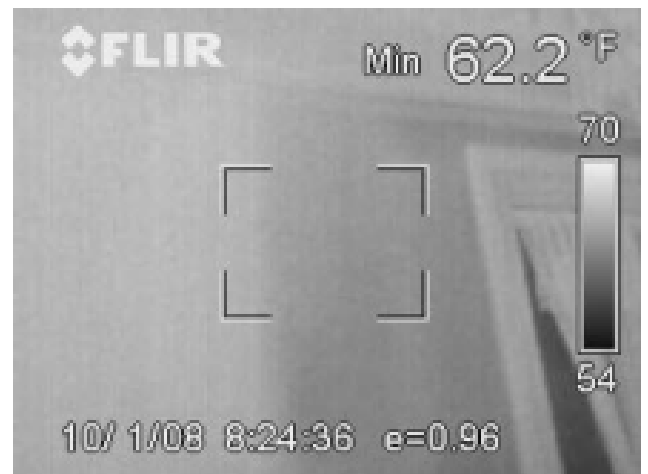
Uninsulated wall

9. Insulate side walls with densely packed cellulose insulation. With brick exterior construction, this would need to be done from the interior which is, of course, disruptive to living conditions temporarily although patching of plaster is easy to do. A test hole can be found in the second floor closet. The walls appear to be a full 4" thick (versus standard 2 x 4 construction of 3.5" giving an additional 1/2" of space).

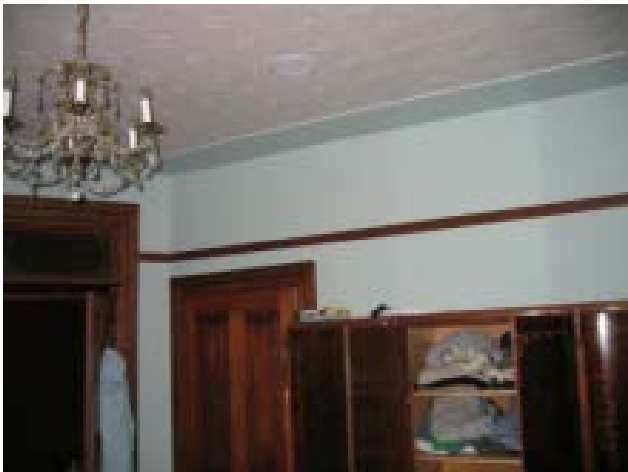
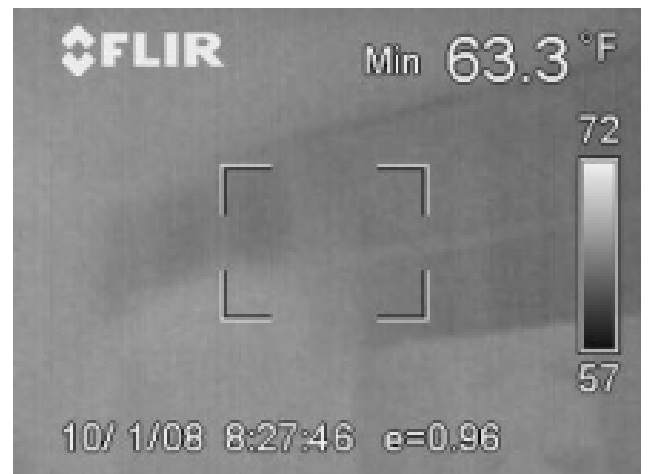
Second floor, interior wall of closet is open to attic

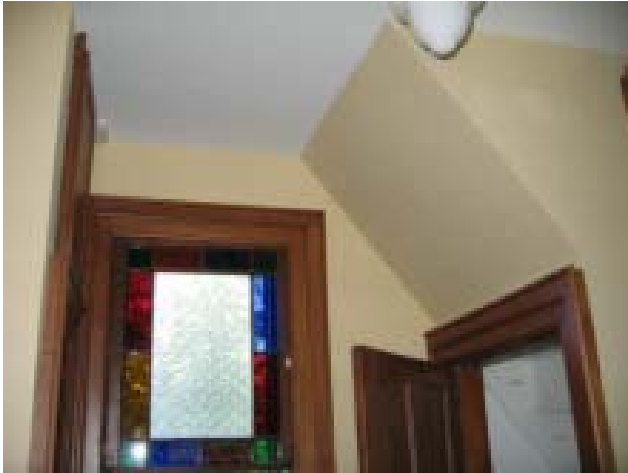
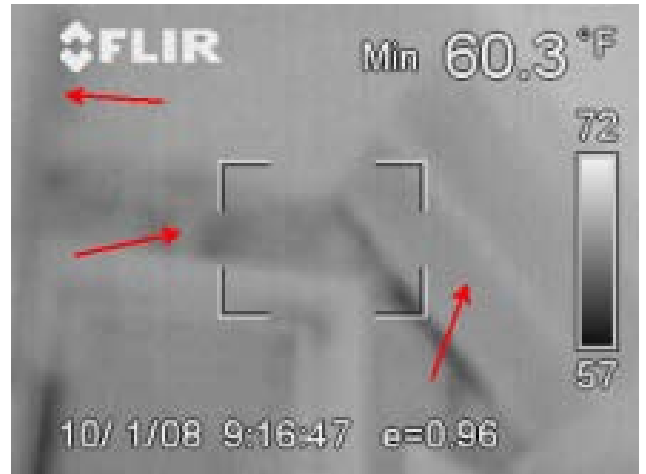
Off kitchen

Shows leaks to the outside

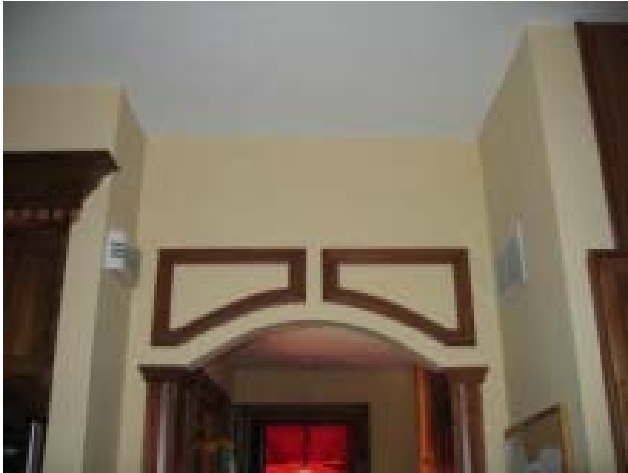
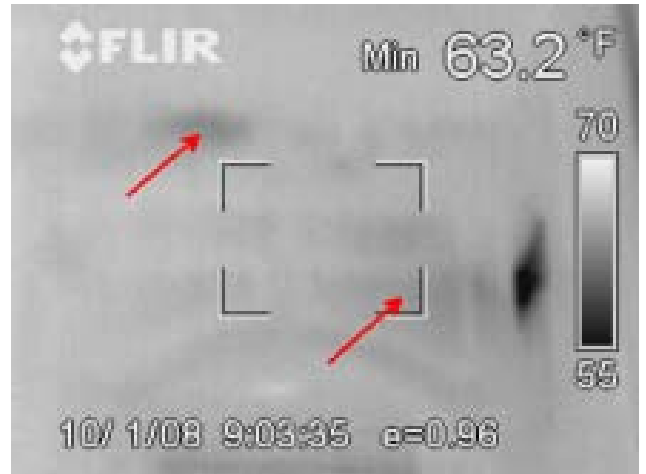
Cool spots in interior section of home

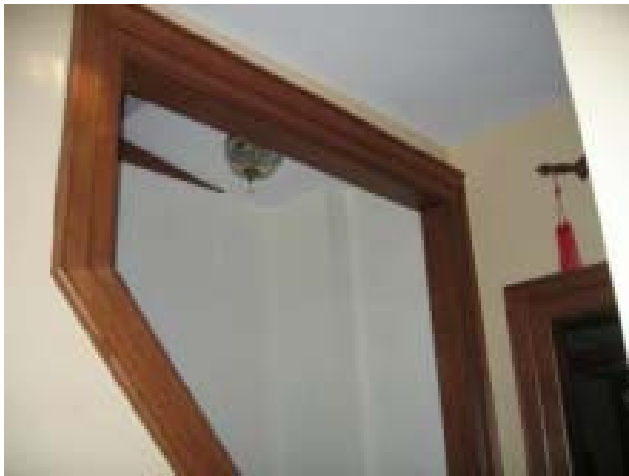
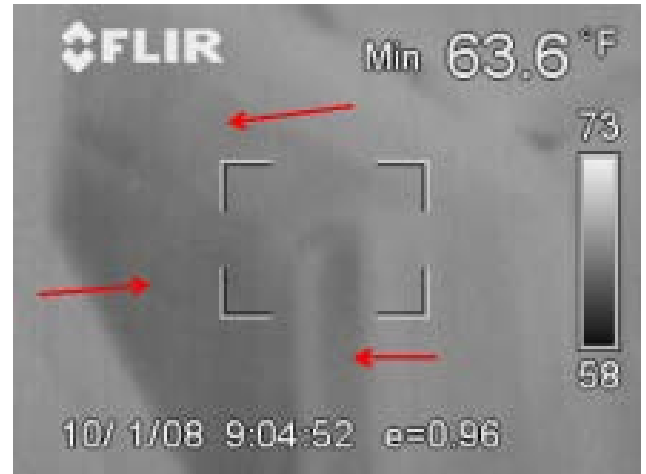
Back stairway

Uninsulated wall and open wall cavity to the outside

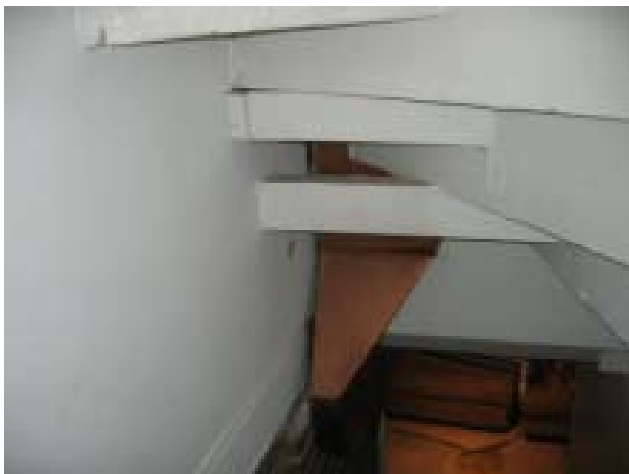
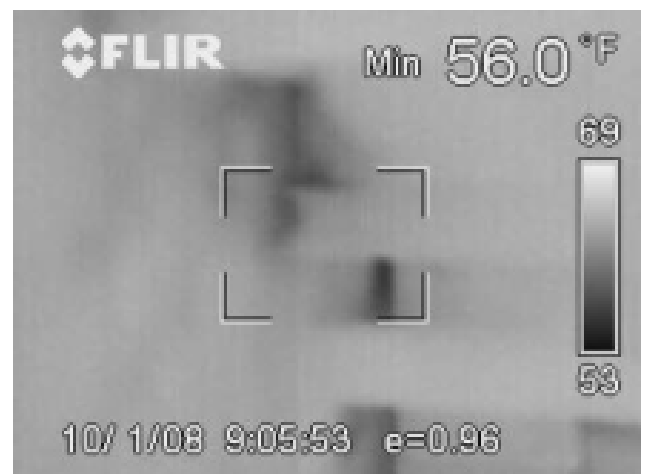
Basement stairs

Needs foaming or other sealant

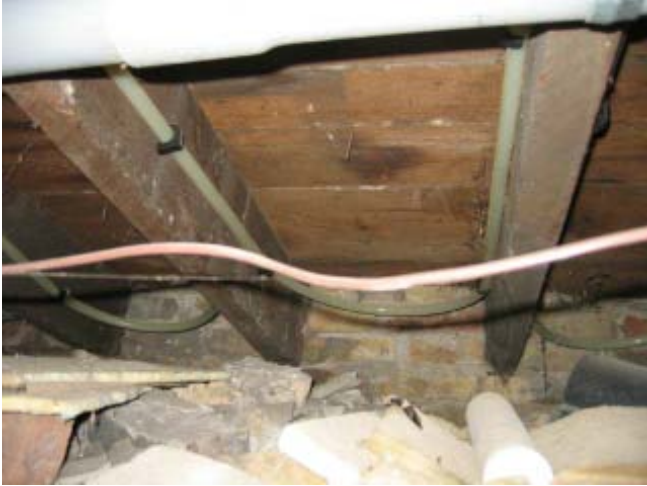
Crawlspace west side. See video of this with blower door running, attached to email message. The crawlspace is a very leaky area.

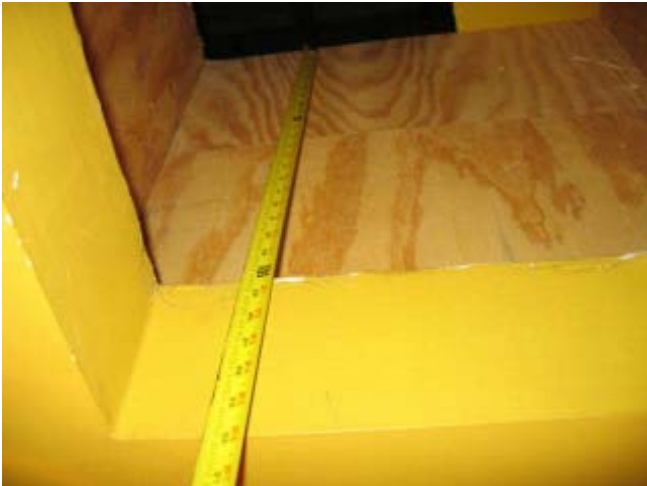
Very tall attic hatch dam made it impossible to pull myself up into the attic. Photos were taken and showed cellulose insulation.

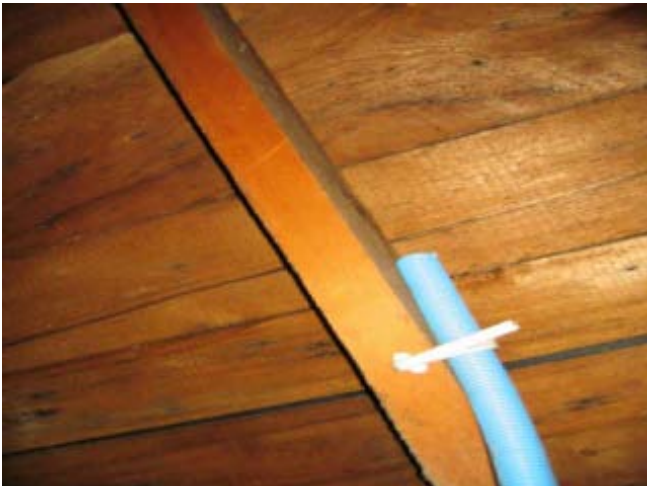
Mysterious blue hose. What is it?
